Part No. 217316-A Rev 00
March 2005

Release Notes for the Passport 8600 Release 3.7.6

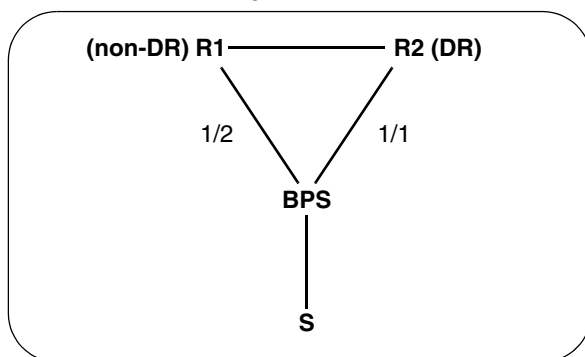
- A non-DR switch receives double traffic when a receiver is connected to a non-DR switch and the unicast route (shortest path) towards the source is not through a DR switch. Both non-DR and DR switches create (\*,G) and (S,G) records. (Q0086744)
- On a VLAN spanning more than two switches, SPT path joins are received on one port of the spanning VLAN. The messages on the VLAN port on which RP-to-source prune messages are received are not properly pruned and stay in a prune pending state (because of overriding joins received on the port in the SPT path). (Q00421566)
- The PIM MRtable incorrectly shows incoming traffic port when there is an SMLT failover. (Q00664751)
- R1 and R2 are running PIM, as shown below:

If the BPS is at the edge, then the BPS always forwards traffic on the lowest link of the MLT. Rebooting the DR switch when traffic is flowing through 1/1, forces traffic to recover through 1/2.

The source->upstream on R1 becomes NULL, because it is getting data locally through 1/2. When R2 comes back up, traffic starts flowing on 1/1 to R2. However, if the unicast route to the source subnet still lies through R1 (since R2 rebooted), any joins to the source go to R1 instead of R2. To receive traffic, R1 must send a join to R2, but because the source->upstream is NULL the join is never sent.
