Part No. 317177-A Rev 00  
May 2004

# Release Notes for the Passport 8000 Series Switch Software Release 3.7

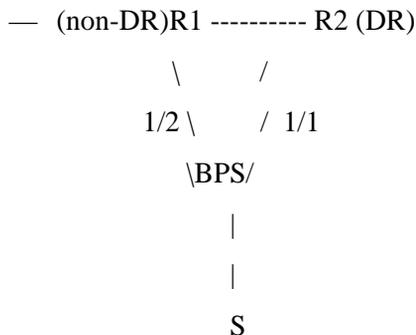
- Non-DR switch receives double traffic when a receiver is connected to a non-DR switch and the unicast route (shortest path) towards the source is not through a DR switch. Both non-DR and DR switches create (\*,G) and (S,G) records. (Q0086744)
- On a VLAN spanning more than 2 switches, SPT path joins are received on one port of the spanning VLAN. The messages on the VLAN port on which RP-to-source prune messages are received will not be properly pruned and will stay in a prune pending state (because of overriding joins received on the port in the SPT path). (Q00421566)
- The PIM MRtable incorrectly shows incoming traffic port when there is an SMLT fail over. (Q00664751)
- R1 and R2 are running PIM:

This issue happens with the BPS at the edge. The BPS always chooses to forward on the lowest link of the MLT. If we reboot the DR switch (traffic was flowing through 1/1), traffic recovers through 1/2.

On R1, since it is getting data locally through 1/2, the source->upstream becomes NULL. When R2 comes back up, traffic starts flowing on 1/1 to R2. However, if the unicast route to the source subnet still lies through R1 (since R2 rebooted), joins to the source will go to R1 instead of R2. Now R1 has to send a join to R2 to receive traffic, but it will not do so since its source->upstream is NULL (it thinks that the source is local).
